APPLICATION FOR FINANCIAL ASSISTANCE
Revised 4/99

PROJECT NAME: Spring Grove/Clifton Improvements

Spring Grove/Clifton Avenue Improvements

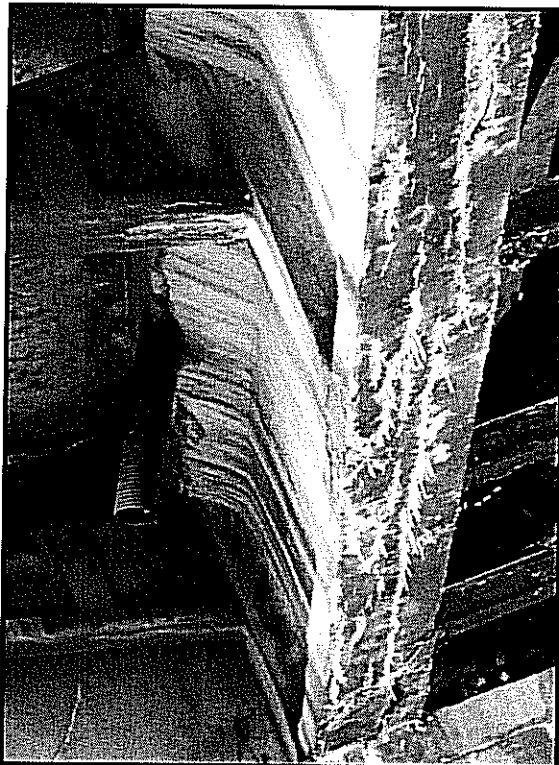
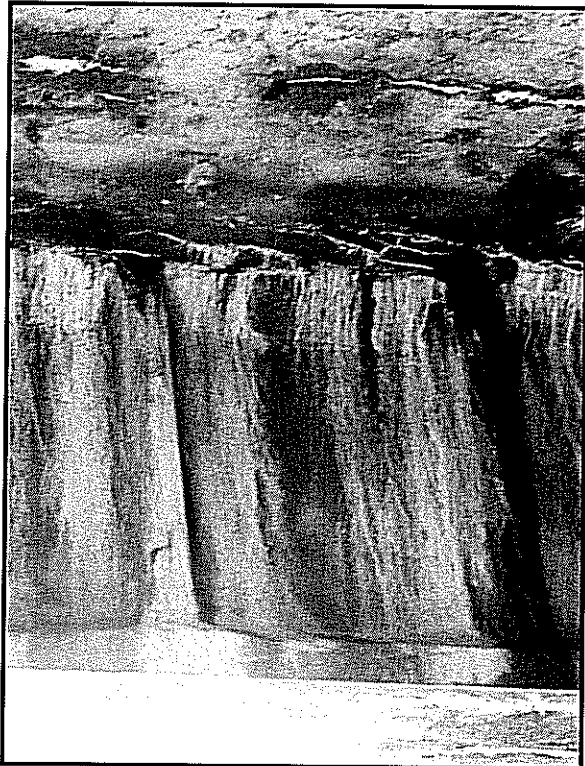
Efflorescence on Girders

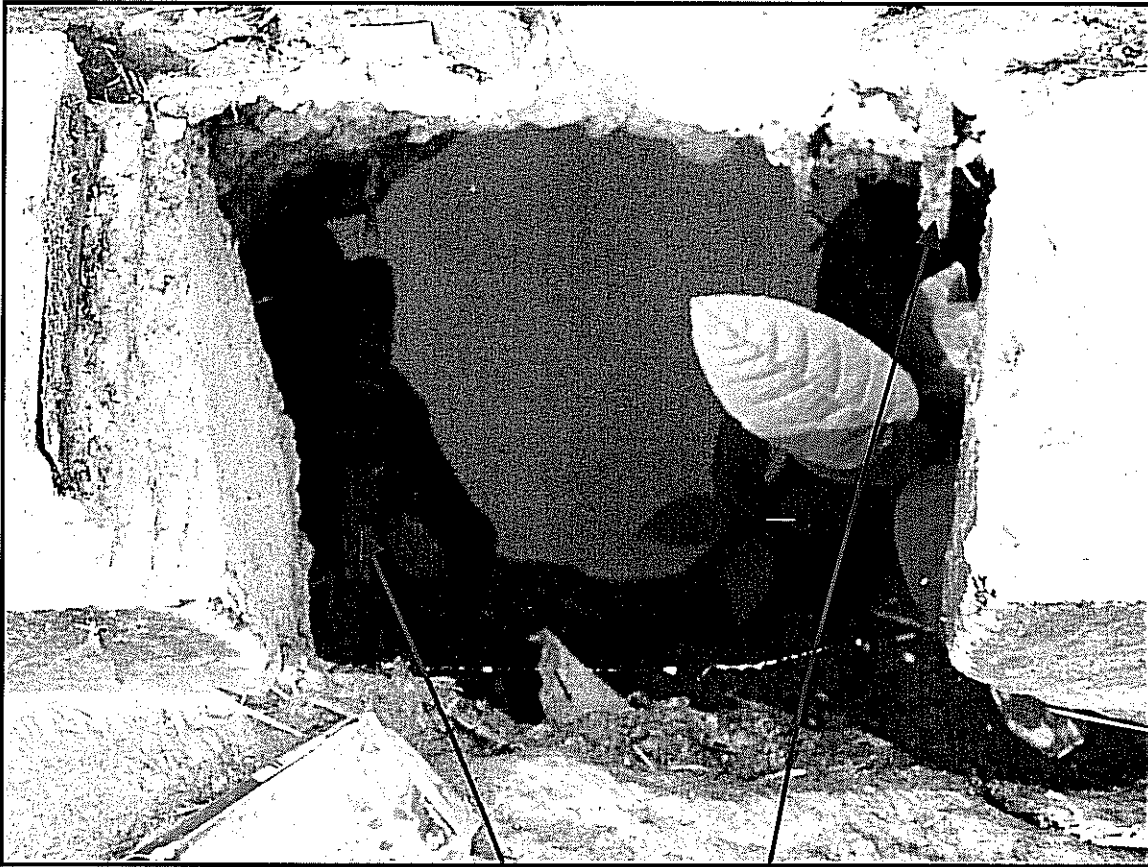
**Spalling at
Scupper**

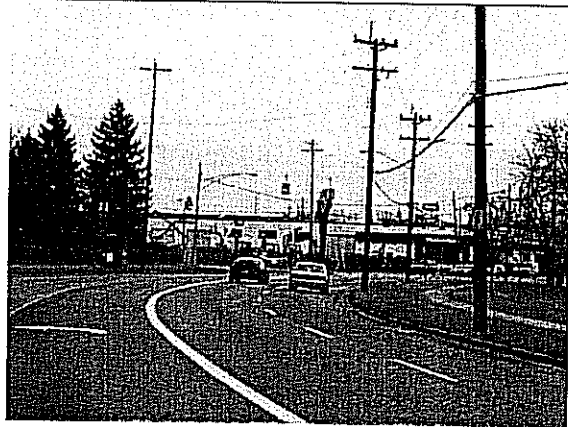
Signal Head Placement: Traffic signals are mounted on span wires at all signalized intersections within the study area. In almost all cases, especially when the intersection is after a horizontal curve, signal displays do not appear to be lined up with the appropriate lane (*right*). This condition increases driver confusion as to which lane is the intended travel lane and increases the potential for rear-end and side-swipe collisions.

traffic signals on eastbound Spring Grove Avenue do not line up with appropriate lanes

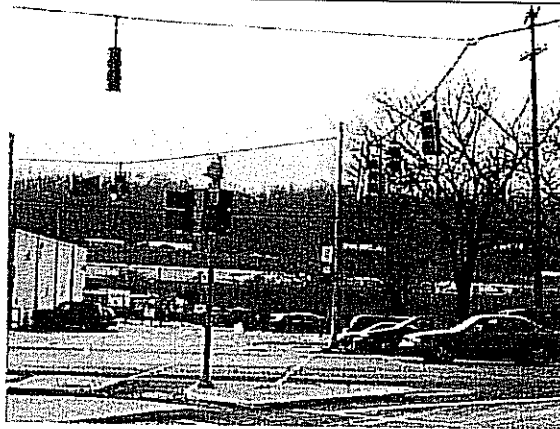
picture of the traffic signal on southbound Winton Rd showing the two right turn green arrows displayed: one from the right turn lane and the other from the shared through/left turn lane

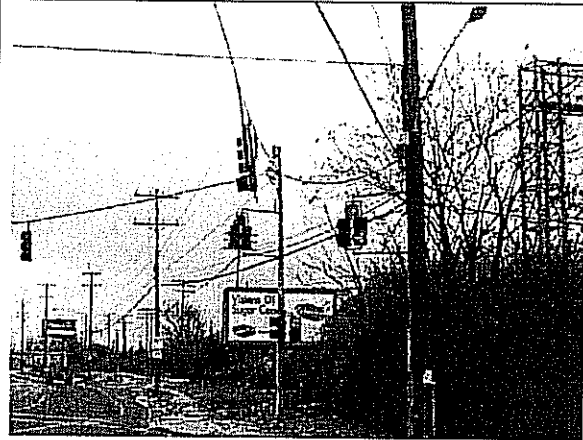
Signal Head Redundancy: Signal head failure, damage, or obstruction (if a driver is following a tall vehicle, for example) may result in unintentional violation of the red light.

picture of the traffic signal on eastbound Spring Grove Av showing the right turn green arrow displayed – there is no redundancy for this signal

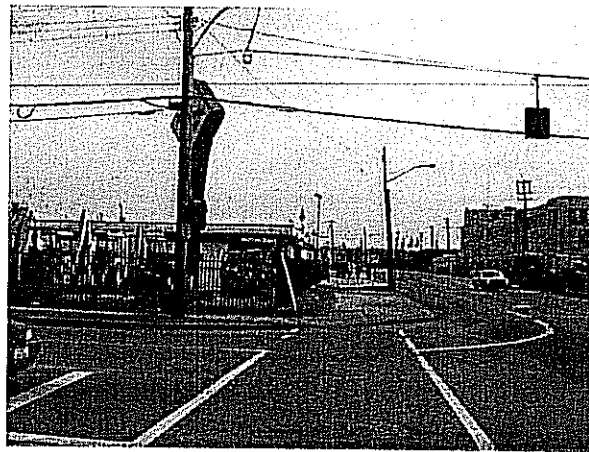
turn radii for dual turns: The turn radii for the dual turns on Spring Grove Avenue are sharp, often resulting in vehicles encroaching into adjacent lanes. The sharp turn radii increase the potential for side-swipe collisions.

small turn radius for dual right turns at intersection of Spring Grove Av and Winton Rd. Dual left turns track to the outside of the right turn pavement marking shown in this picture.

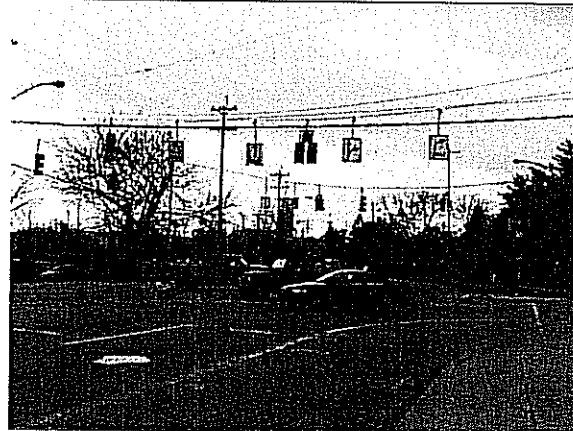
concurrent dual turns (right turns and left turns): Traffic signal phasing provides concurrent green intervals to dual right turning and (from the cross-street) dual left turning traffic. The concurrent dual turn movements, combined with the limited available turn radii, increase the opportunity for head-on and side-swipe collisions. Two locations currently provide this condition: the intersections of Spring Grove with Winton Rd (*right*) and Clifton Av.

dual left turns from southbound Winton Rd often encroach into opposing dual right turn lanes

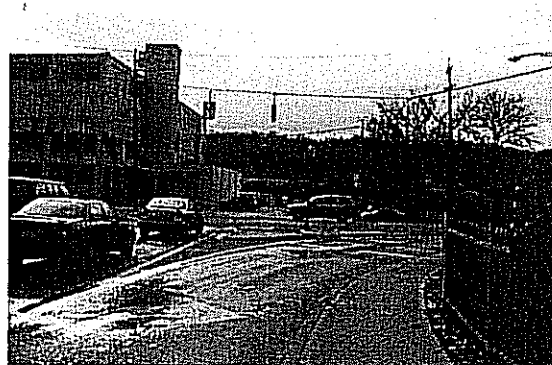
Southbound right turn at Spring Grove/Winton: The channelized right turn with traffic signal control is not a typical configuration. Usually, channelized right turns are not traffic signal controlled and drivers may not pay attention to traffic signal based on prior experience. This could result in an increase of rear-end, side-swipe, and angle collisions.

channelized right turn on southbound Winton Rd showing red signal indication

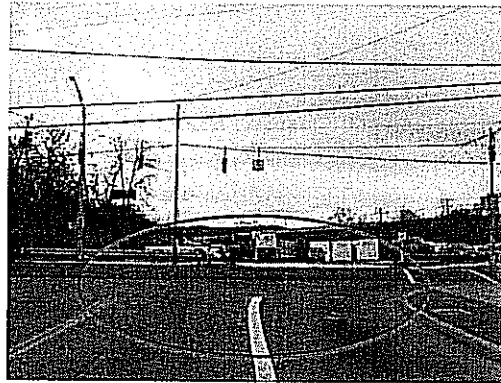
stop bars and pavement arrows are barely visible on the east leg of the intersection of Clifton and Kenard

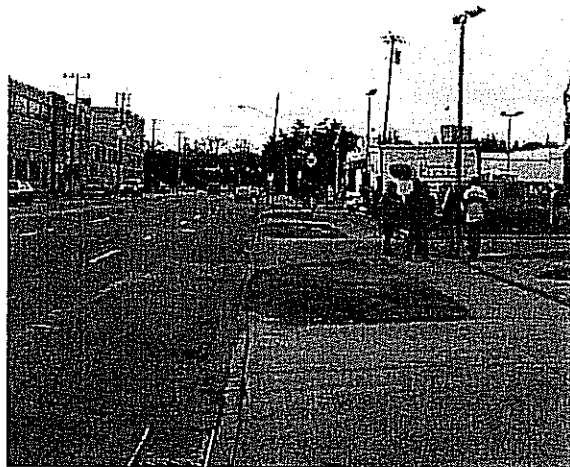
Six driveway access points are on the north side of Spring Grove Avenue between Clifton Avenue and Winton Road (a distance of about 950 feet) serving the commercial and industrial developments on that side of the street (*right*). The accesses generate accelerating, decelerating, and turning (right-turn and left-turn) movements that interfere with through traffic on the arterial road. Station

*multiple accesses on the north side of Spring Grove Av
increase conflict points*

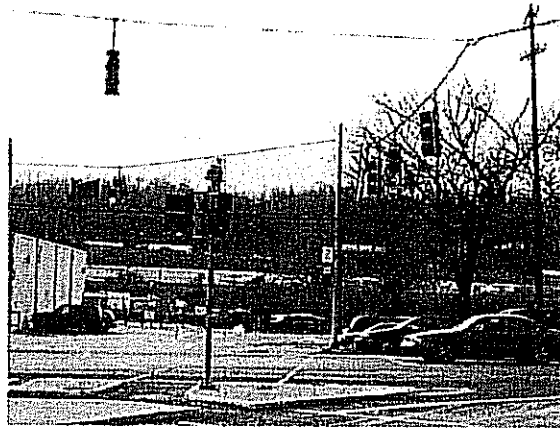
Access at (and closer to) the intersections. The driveway to the parking lot on the south leg to the intersection of Spring Grove Avenue and Winton Road has two three-lens display traffic signals for traffic control. When eastbound or westbound traffic on Spring Grove Avenue has a green light the traffic signal for the south leg is red. When southbound traffic on Winton

Driveway to parking lot on south leg of intersection of Spring Grove Av and Winton Rd

road has a green light the traffic signal for the south leg turns to flashing red then to yellow and back to red. The green signal display is apparently never used. Traffic turning left out of this lot conflicts with the southbound left turning traffic coming from Winton Road. Vehicles waiting to make a left turn into the parking lot from westbound Spring Grove Avenue sometimes partially block the path of southbound left turning traffic coming from Winton Road. This driveway configuration may contribute to the angle and side swipe conflicts at the intersection.

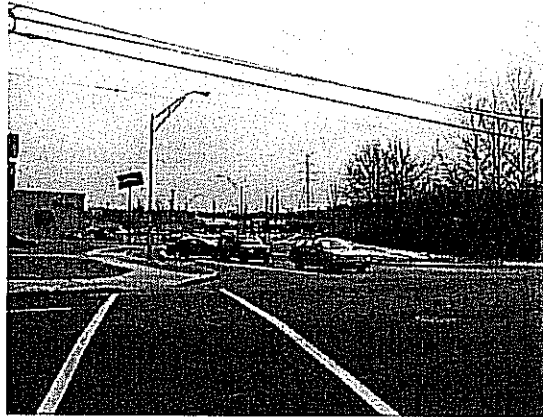
Traffic using the western driveway at the Blockbuster Video, which is located about 50 feet to the east of the intersection of Clifton Avenue and Kenard Avenue, often conflicts with traffic at the intersection. Traffic turning right out and attempting to turn left at the intersection of Clifton Avenue and Kenard Avenue often blocks the right turn lane, creating another conflict point close to the intersection and increasing driver frustration.

Traffic exiting Blockbuster and turning left often blocks the right turn lane even with light traffic due to the proximity of the driveway to the intersection

Traffic should be accommodated adequately at the driveway to the east.

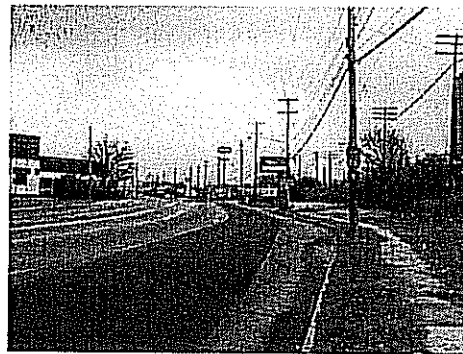
eastbound Spring Grove Avenue: The right lane east of the intersection is currently wide enough to accommodate two lanes, but is marked for only one lane. The resulting wide single lane was observed to cause confusion when drivers' perceptions of the number of travel lanes were not consistent. Sideswipe collisions may result when one driver attempts to bypass another who is unprepared to share the unmarked approach lane.

wide right lane on eastbound Spring Grove Av is sometimes mistaken for two lane by motorists

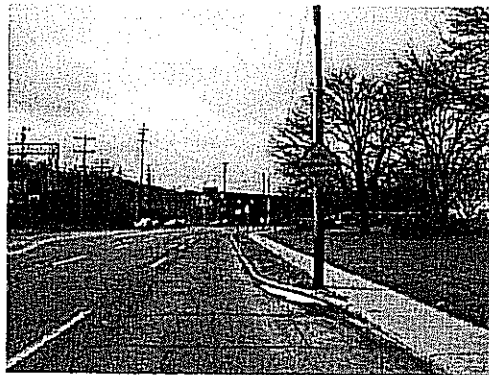
westbound Spring Grove Avenue: Due to the geometry of a bus bay, the right lane appears to suddenly narrow as drivers approach the intersection with Clifton Avenue. This creates a hazard which is compounded by the presence of a utility pole.

abrupt lane narrowing at westbound Spring Grove Av

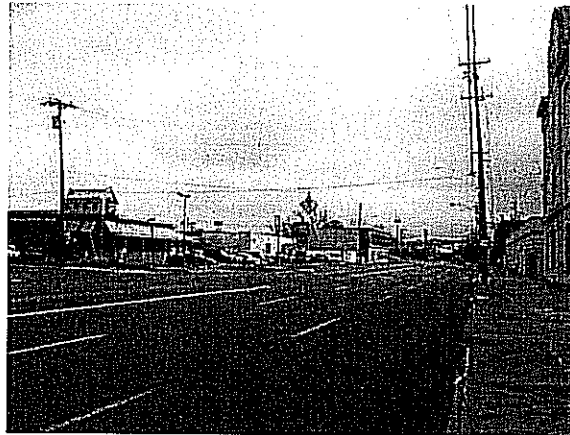
crosswalk at Spring Grove Avenue near intersection with Station Avenue: Crosswalk pavement markings are inconspicuous, which may increase the risk to pedestrians crossing the street. Conspicuity is particularly important based on the speeds of vehicles on the road. The presence of a clearly visible pedestrian crossing facility is especially important at this location, where pedestrians walking to and from bus stops on both sides of the road can be expected.

crosswalk near Station Av is also inconspicuous during the day

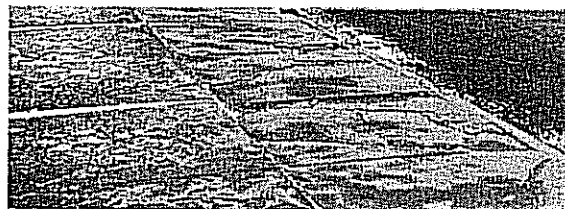
sidewalk condition, especially trip hazards: The sidewalk along Spring Grove Avenue is poorly maintained, increasing risk of injury to pedestrians.
